## FIELD PICTURES # 1

The morning session was indoors with a picture presentation of the topic. The afternoon session was outdoors with a visit to near-by sites of interest.

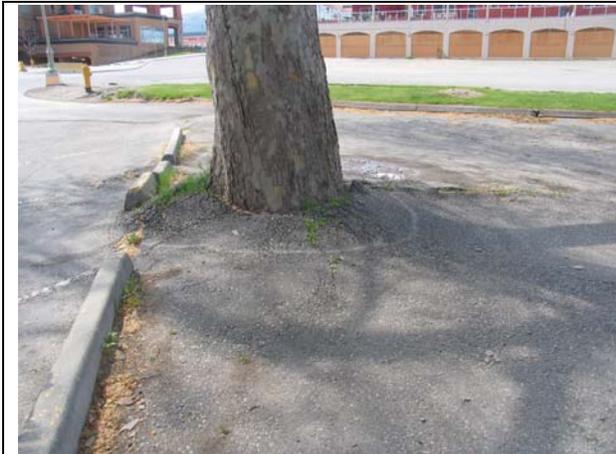
Left: Damage by trunk flare occurs when there is lack of space to accommodate growth. An opening must be created to repair and retain the tree. Root pruning is not possible. Right: Shallow roots in contact with pavement are growing larger and causing damage. Repair will require root pruning and changing the sidewalk materials.

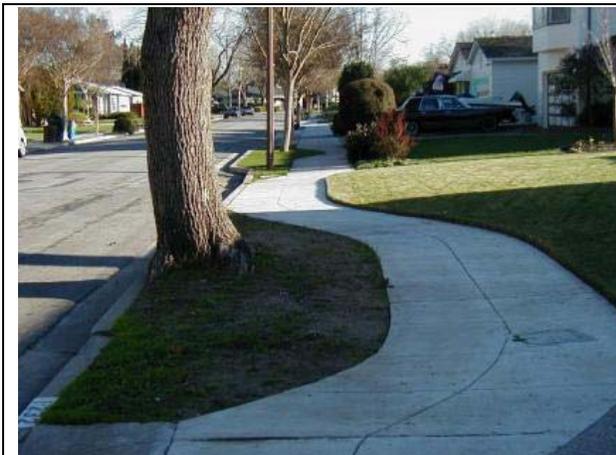
Left: The sidewalk was installed away from the tree. Right: Sidewalk built with decomposed granite walkway. Both pictures by the speaker.

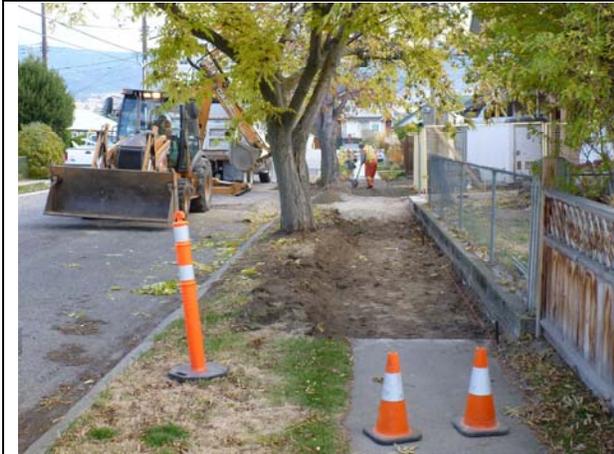
Left: Sidewalk repair where tree roots caused pavement lifting.

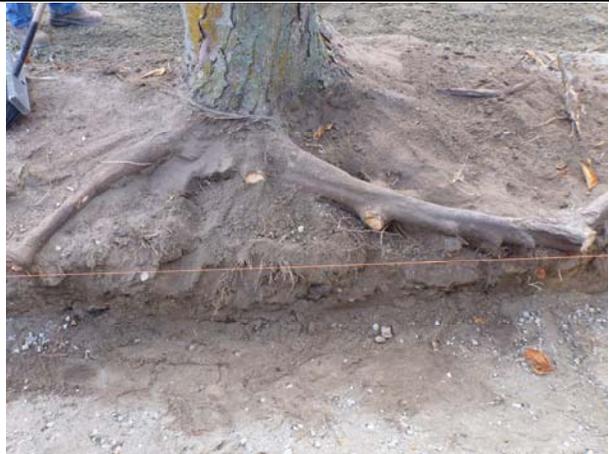
Right: To ensure tree survival, root pruning should be on roots smaller than 5-cm diameter and start 25 to 30-cm away from the trunk.

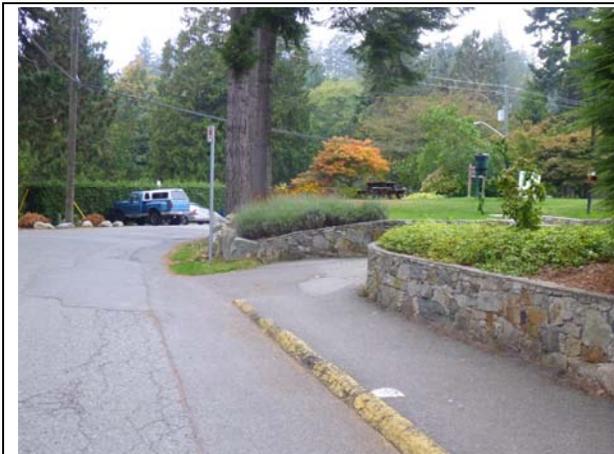
Left: An interim solution is to build a new sidewalk away from an existing tree.

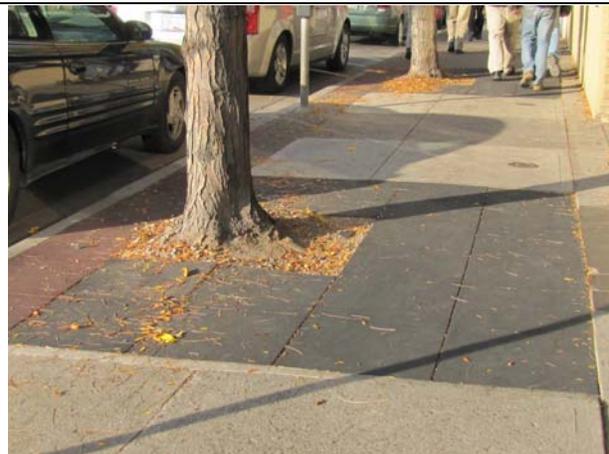
Right: Another interim solution is to use rubber panels installed over the tree roots.

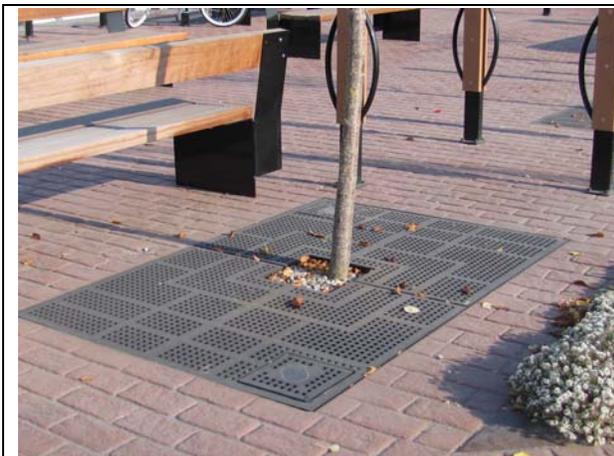
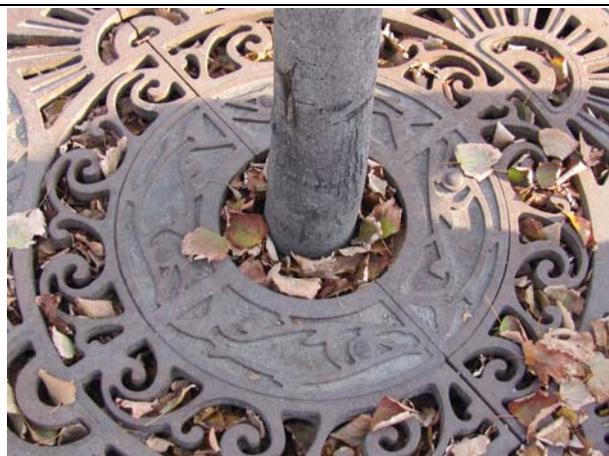
Above: Larger tree grates will move the concrete footing farther away from the tree.
