## **Sidewalk and Roots: Mitigating the Conflict—*An Overview***

by Gordon Mann, Consulting Arborist, Mann Made Resources, Auburn, California

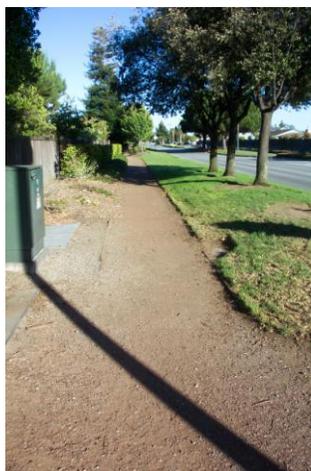
Decomposed Granite walkway

**Decomposed Granite, aka Fine Rock Dust** – On the plus side, this material can be lower cost and maintained by adding more or by re-grading. A binder can be used to help keep it together. Its border can be shaped, it can be laid over roots, and it doesn't need a deep base that can be placed over roots. On the minus side, it requires an edge band on the sides to hold it in place, and this band can be lifted by roots. Also, the surface typically needs more maintenance and it has the potential for dust to be tracked into homes and businesses. It can erode on slopes and transition points with other solid materials. The appearance may not be acceptable in some urban settings. The thickness is mid to upper range, and once compacted is not very porous.

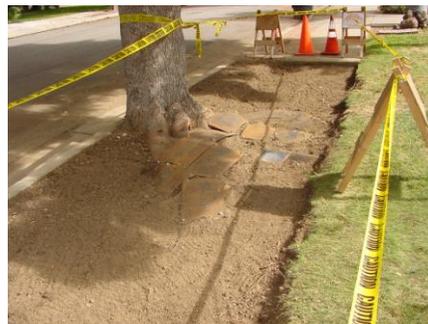
Sunnyvale, CA steel plates over roots

**Sunnyvale's Steel Plates** - An innovative method practiced for more than 20 years in Sunnyvale, California is to use steel plates to limit the future growth of the root towards the concrete improvement (see photo). Steel plates of 1/8" thickness are bolted on top of the root or placed on opposite sides of the root and bolted together, sandwiching the root. Future root growth cannot push the steel apart or away - the root flattens against or between the plates. Plates are placed under or adjacent to the sidewalk to strategically limit future radial growth. This technique is more expensive than root pruning and it takes time to perform the plate sizing work. However, Sunnyvale has not had to return to these sites for root conflicts and the trees are more stable than if they were root pruned.

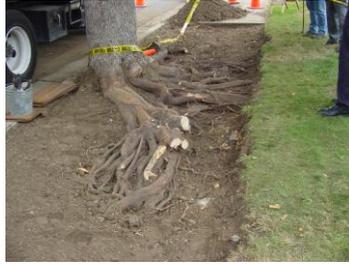
Selective root pruning,  
Sunnyvale, CA

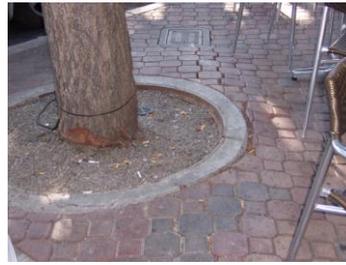
Concrete ring raised by roots  
Trunk is so large the grate was  
replaced with DG

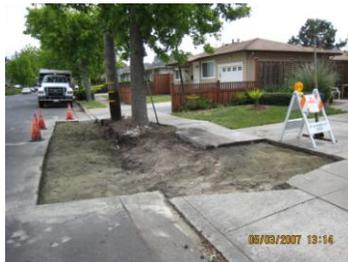
Large roots under sidewalk and  
driveway

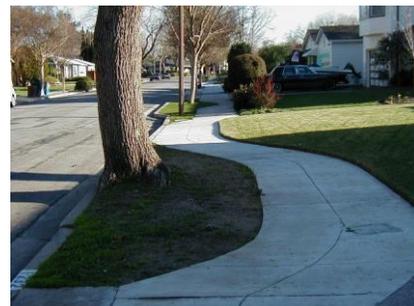
3 different sidewalk treatments; move away  
from tree, move sidewalk next to curb, move  
both sidewalk and curb away
